11 February 2000
B-H200-16888-ASI

Subject: Engine Fuel Flow FDR Data – Egyptair 767-300ER SU-GAP,
Accident Off Nantucket, Massachusetts – 31 October, 1999

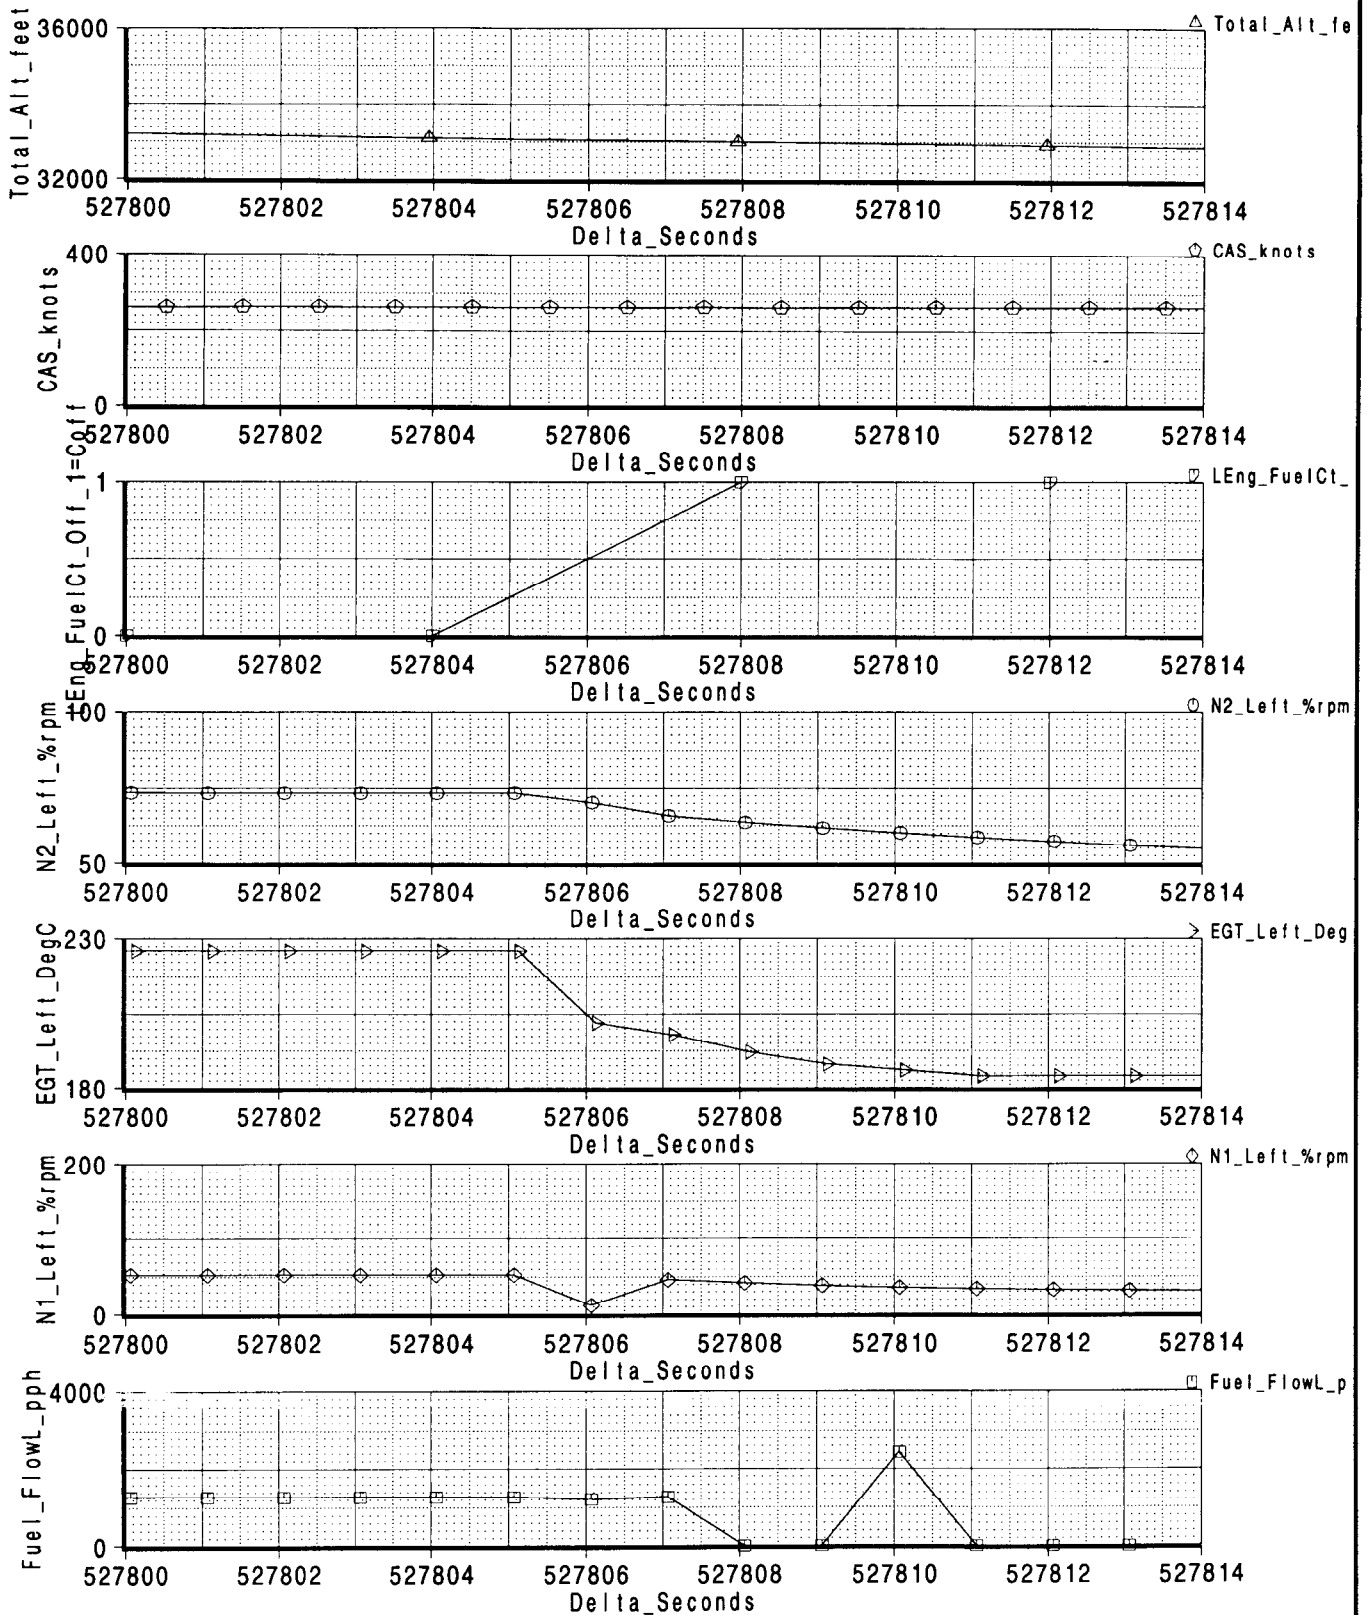
CALC		12Jan00	REVISED	DATE	767 / PW4000 / AMETEK FLOW METERS	
CHECK					LEFT ENGINE SHUTDOWN	
APPD.					B1 FLIGHT, 1-11-2000	
APPD.					BOEING	PAGE

3. Following "fuel shutoff" (as defined by the initial decay in engine parameters), the left engine fuel flow remained at idle flow for 2 - 3 seconds, then showed a flow of zero. Five seconds after fuel shutoff, the left engine fuel flow showed a spike to 2400 lbs./hr (1100 kg/hr) for one data point, then back to a steady flow of zero.

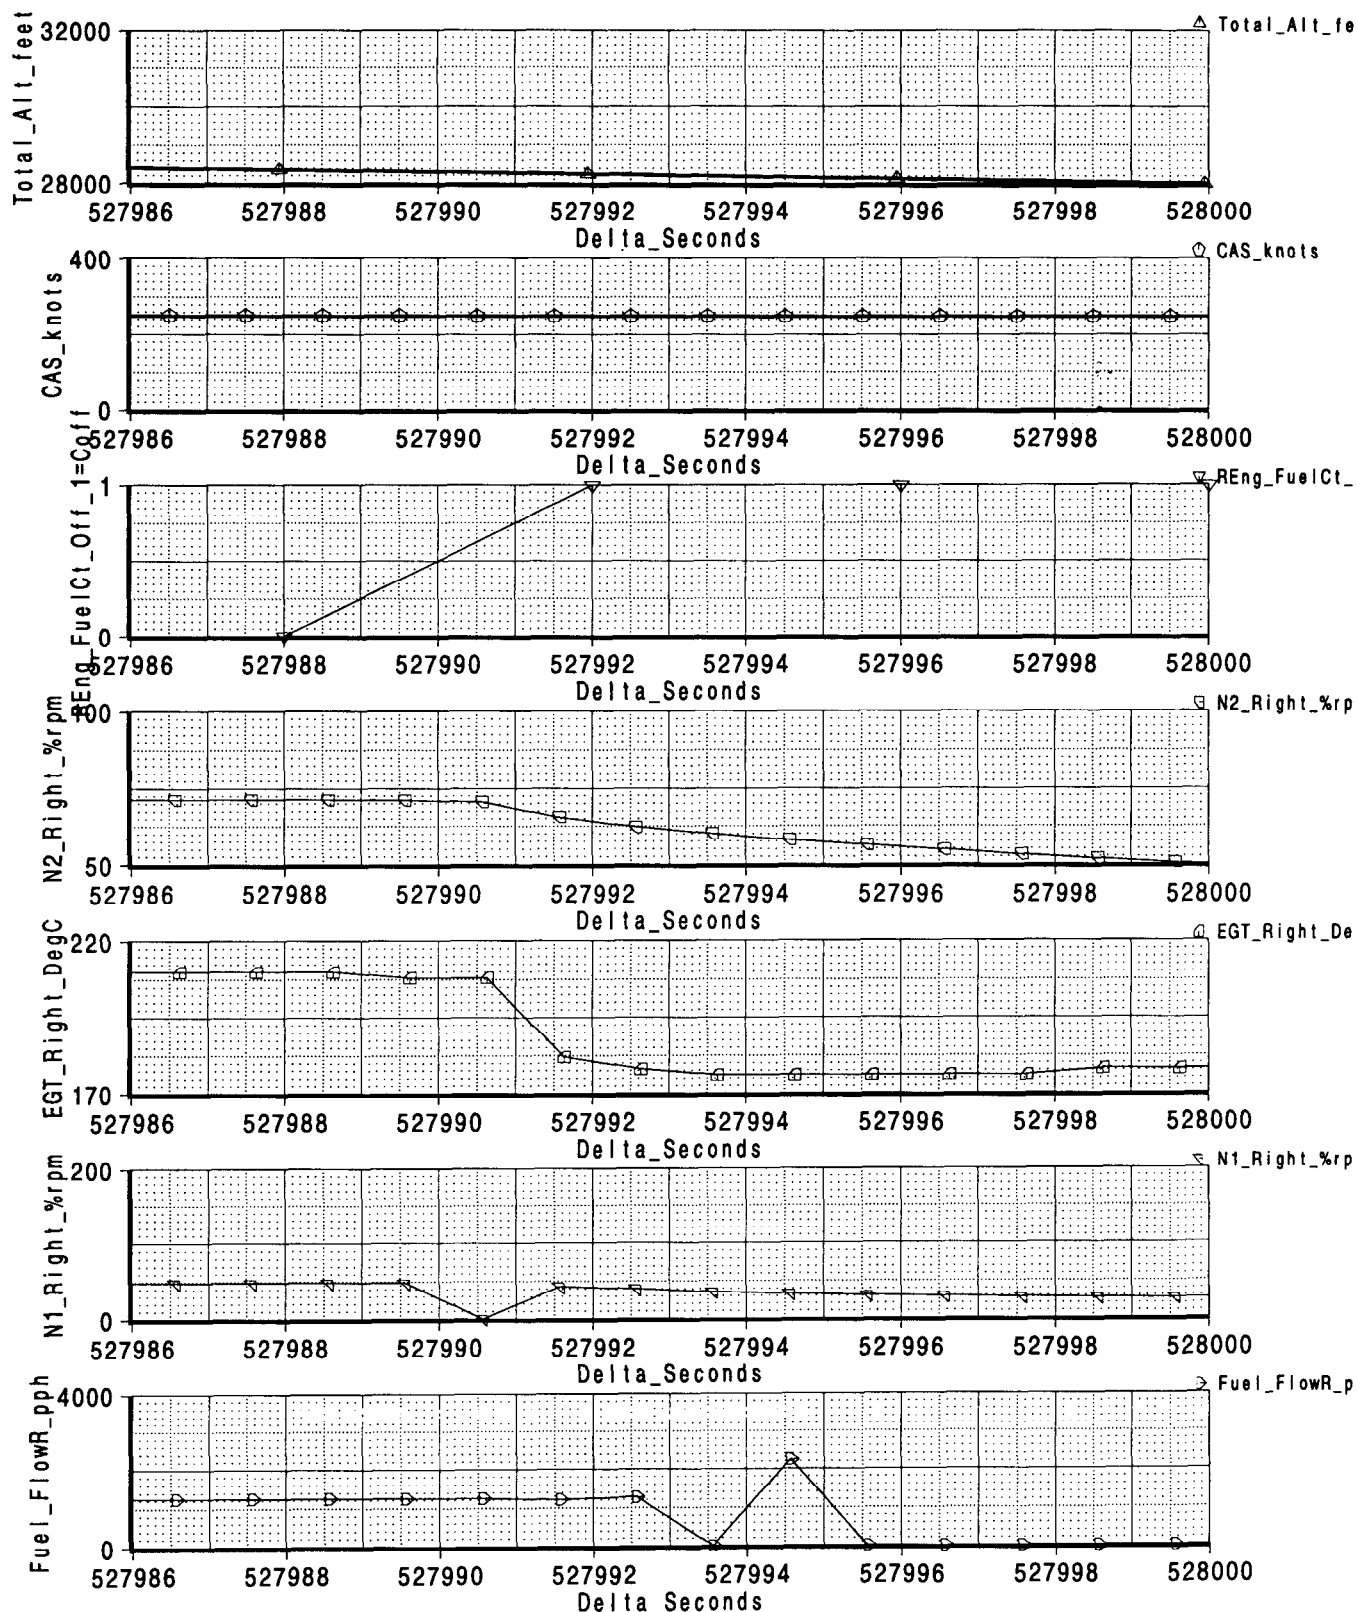
CALC		12Jan00	REVISED	DATE	767 / PW4000/ AMETEK FLOW METERS RIGHT ENGINE SHUTDOWN B1 FLIGHT, 1-11-2000 BOEING	
CHECK						
APPD.						
APPD.						PAGE

4. Following "fuel shutoff", the right engine fuel flow remained at idle flow for 2 - 3 seconds, then showed a flow of zero. Four seconds after fuel shutoff, the right engine fuel flow showed a spike to 2200 lbs./hr (1000 kg/hr) for one data point, then back to a steady flow of zero.
